UNITED STATES NAVY - CANADIAN FORCES
SOLID STATE FLIGHT DATA RECORDER/CRASH POSITION LOCATOR
EXPERIMENT ON THE B-720 CONTROLLED IMPACT DEMONSTRATION

D. M. WATTERS
Naval Air Test Center
Patuxent River, Maryland 20670-5304

NASA/FAA Government/Industry CID Workshop
NASA Langley Research Center
April 10, 1985

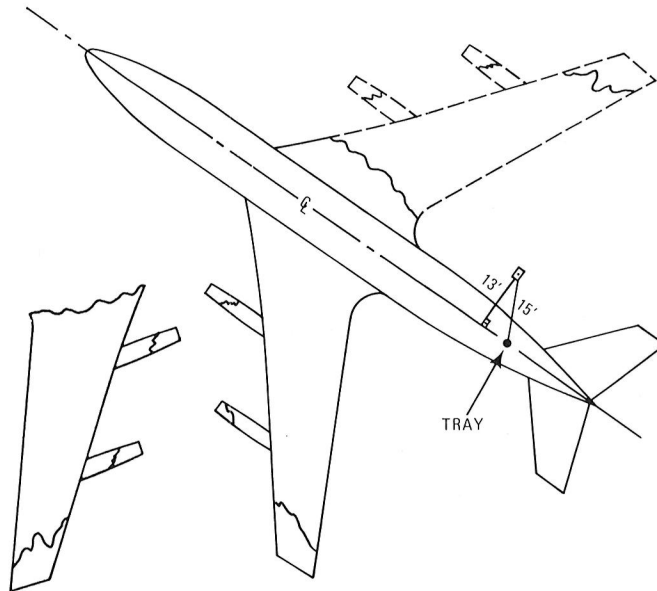
Figure 7
RBA-46 LOCATION RELATIVE TO B-720 AFTER CID

Navy personnel access to the crash site was allowed on the morning of December 2, 1984. The CPL RBA-46 was found resting top side up, 15 feet forward and 13 feet perpendicular from the tray location on the starboard side of the aircraft. Figure 7 shows the final location of the CPL RBA-46. An immediate inspection indicated the airfoil suffered moderate fire damage with paint peeling but not intumescing. The visual marker strobe lamp housings were intact but extensively burned such that it was impossible to see if the lamps had survived. The airfoil suffered minor structural damage, with assorted dents, etc. The SSFDR cavity was intact with the top surface of the recorder being blackened by fire. Figures 8 and 9 show the CPL RBA-46 as found at the B-720 crash site.

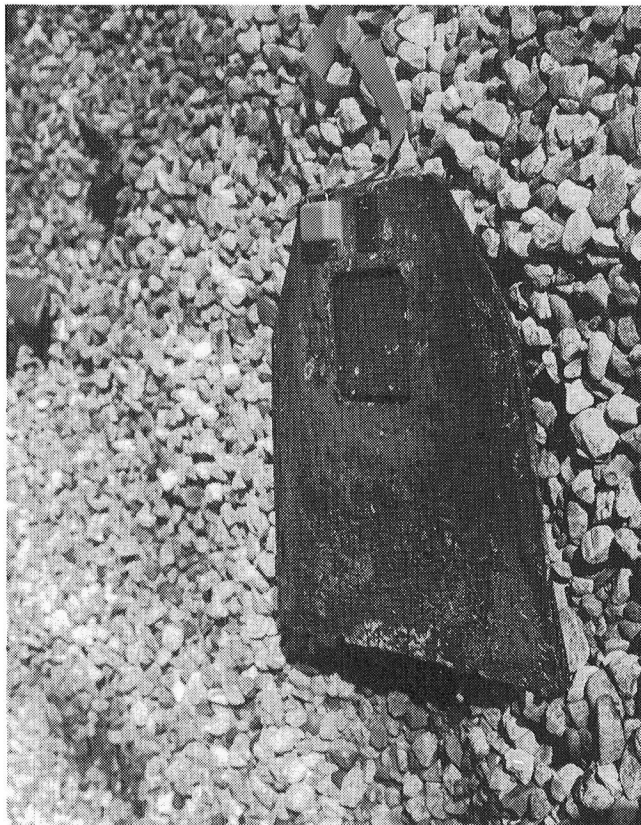
Figure 8
RBA-46 EXTERNAL SURFACE AFTER B-720 CID

The extended plunger on the ARU-21 release unit indicated that the pyrotechnic deployment system operated. The radio beacon base (tray) suffered some heat and fire damage, and was charred and blackened by smoke.

Initial inspection showed charring on both sides of the airfoil. Structurally the airfoil was intact with various dents, etc. on its surface. The airfoil was soaked in fluids which were a combination of antimisting kerosene (AMK) jet fuel and fire fighting foam. Henceforth this fluid will be referred to as "crash fluid".

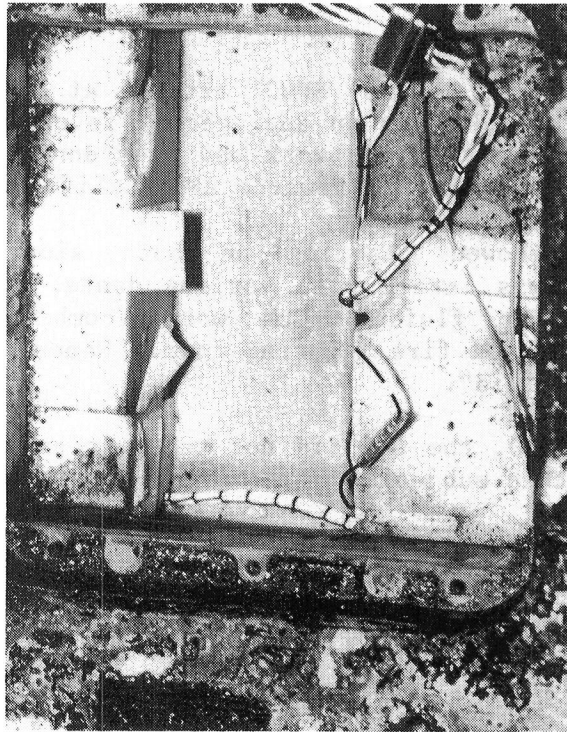
Figure 10
RBA-46 PAYLOAD CAVITY WITH SSFDR REMOVED

The SSFDR was removed from the RBA-46 airfoil to provide access to the CPL payload cavity. Each assembly was then tested to determine its state. Figure 10 shows the payload cavity before disassembly.

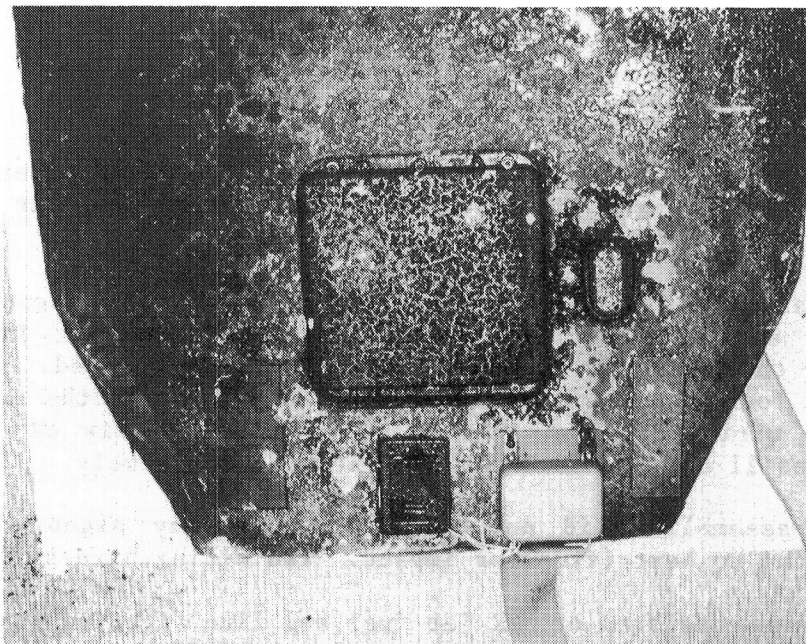
Figure 11
RBA-46 SSFDR EXTERNAL SURFACE PRIOR TO DISASSEMBLY

The SSFDR case was wet with crash fluids. All the assemblies in the cavity had their encapsulating foam soaked with crash fluids. The fluids had seeped in around the SSFDR because there was no seal installed. Sediment due to corrosion was found on the SSFDR connector as well as on the surface of the foam and on the wiring harness. These consisted primarily of green copper deposits. Figures 11 and 12 show the SSFDR before disassembly.

The SSFDR case cover top was scorched extensively but the intumescent paint did not intumesce. The underside was wet with crash fluids, with evidence of smoke.

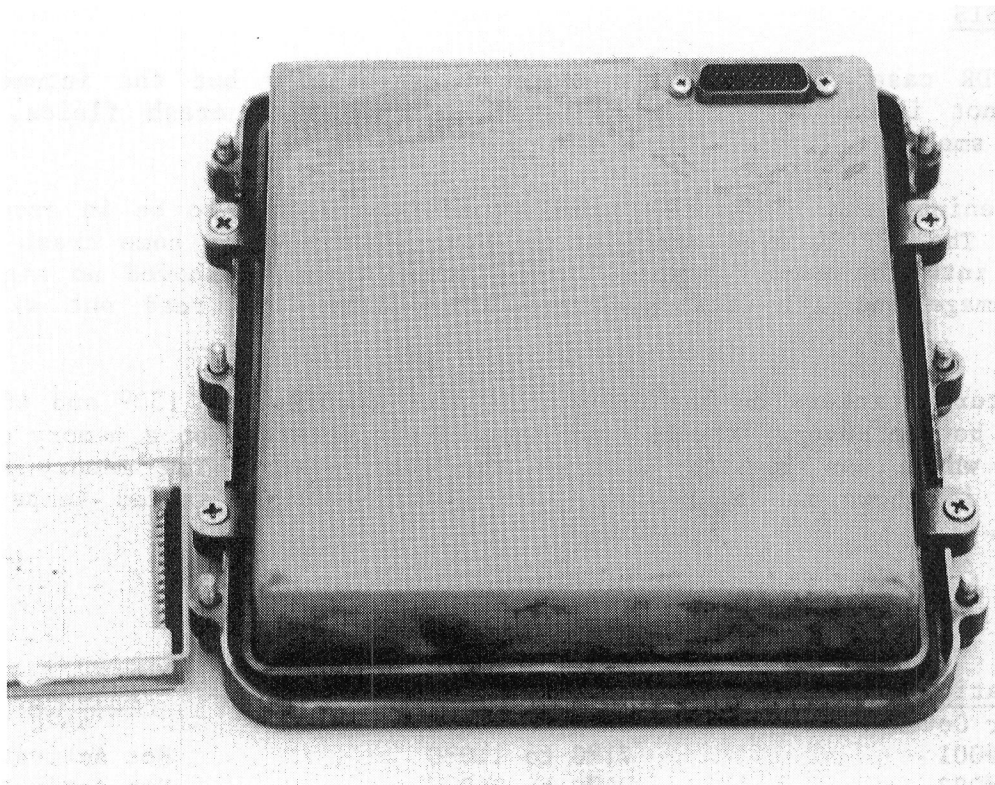
Figure 12
SSFDR INTERNAL SURFACE AFTER B-720 CID

Upon opening, the interior of the recorder was found to be in excellent condition. The SSFDR cover seal was in good shape however some crash fluid had seeped into the memory modules. The memory modules showed no signs of physical damage and all data (checkerboard pattern) was read out with no errors.

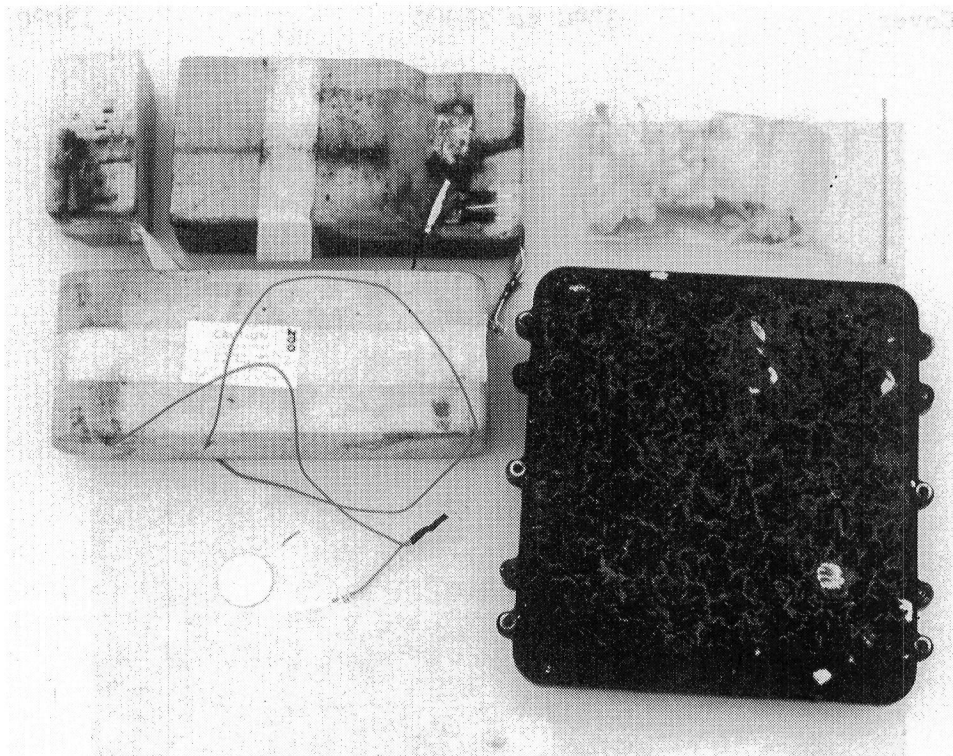
Figure 13
RBA-46 PAYLOAD COMPONENTS REMOVED FROM CAVITY

The crash fluids consisted of AMK jet fuel and fire fighting foam. The fire fighting foam is electrically conductive, very corrosive and has a very low surface tension. Low surface tension allows it to flow rapidly into cracks, etc. This fluid extensively damaged various components of the airfoil payload as shown in figure 13.
